Manhole Inspection Summary

Manhole # S25GG_042MH

Insp Date: **10/10/07 9:58 AM**

Location Address: **1374 STOCKTON ST**

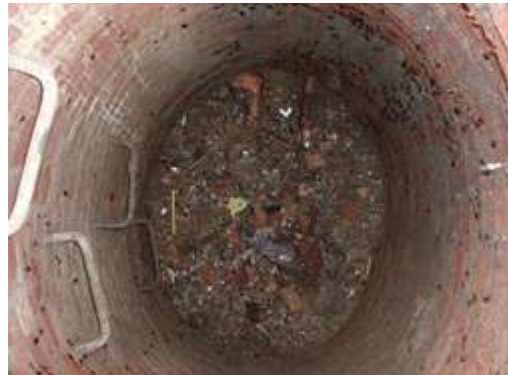
Top View

Corroded steps. Channel debris.

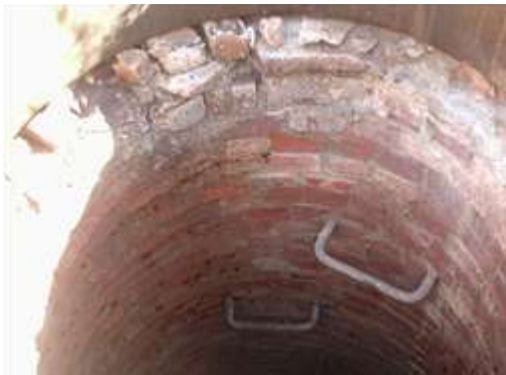
Defect

Frame leaks. Frame offset. Adjustment deterioration, loose brick and infiltration. Corbel and Barrel infiltration - other side.

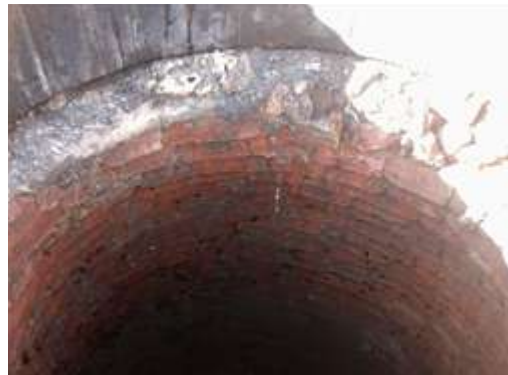
Defect

Frame leaks. Frame offset. Adjustment deterioration, loose brick and infiltration. Corbel and Barrel infiltration.

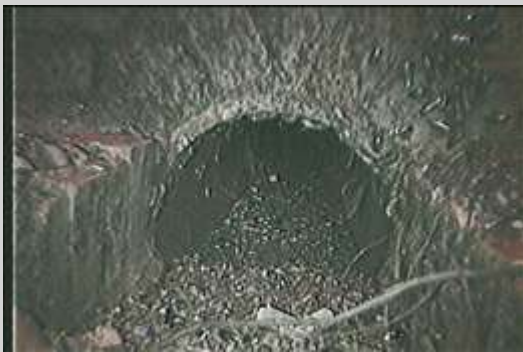
8 in. Circular Gravity Sewer
Pipe Out @ 12 O'Clock

Deposits: ☐ None ☒ **Mud** ☐ Sludge ☒ **Debris** ☐ Grease

Silt Depth: **2** (in.) Deposits Extent: **Light**
